Maryland Inventory of Historic Properties number: WA-II-1117

Name: W-5372/OLD ROXBURY RD OVER BEAVER CREEK

MARYLAND INVENTORY OF HISTORIC BRIDGES  
HISTORIC BRIDGE INVENTORY  
MARYLAND STATE HIGHWAY ADMINISTRATION/  
MARYLAND HISTORICAL TRUST

SHA Bridge No. W-5372 Bridge name Old Roxbury Road over Beaver Creek

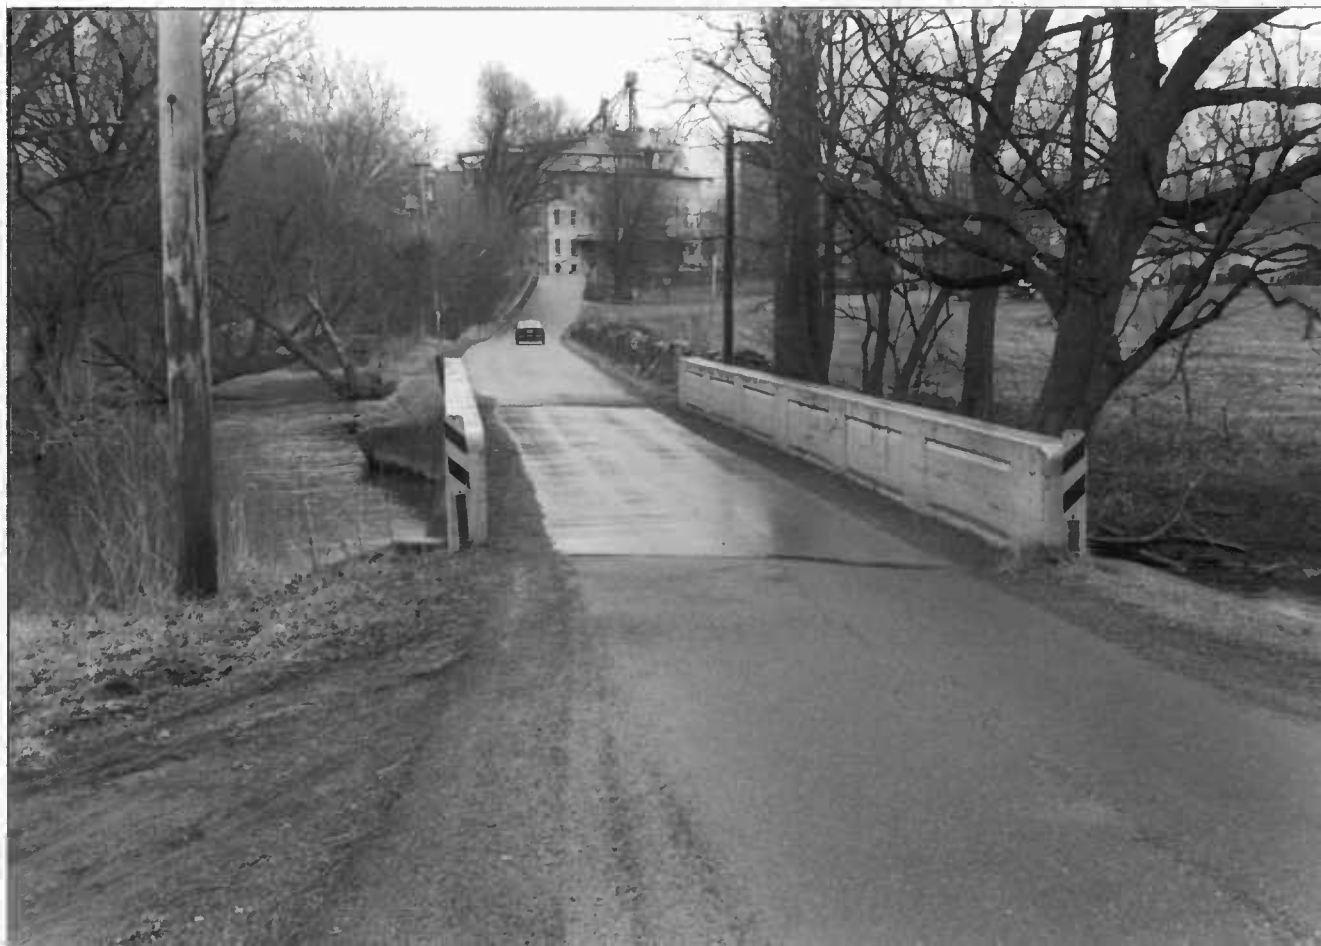
1 OF 4

WEST APPROACH

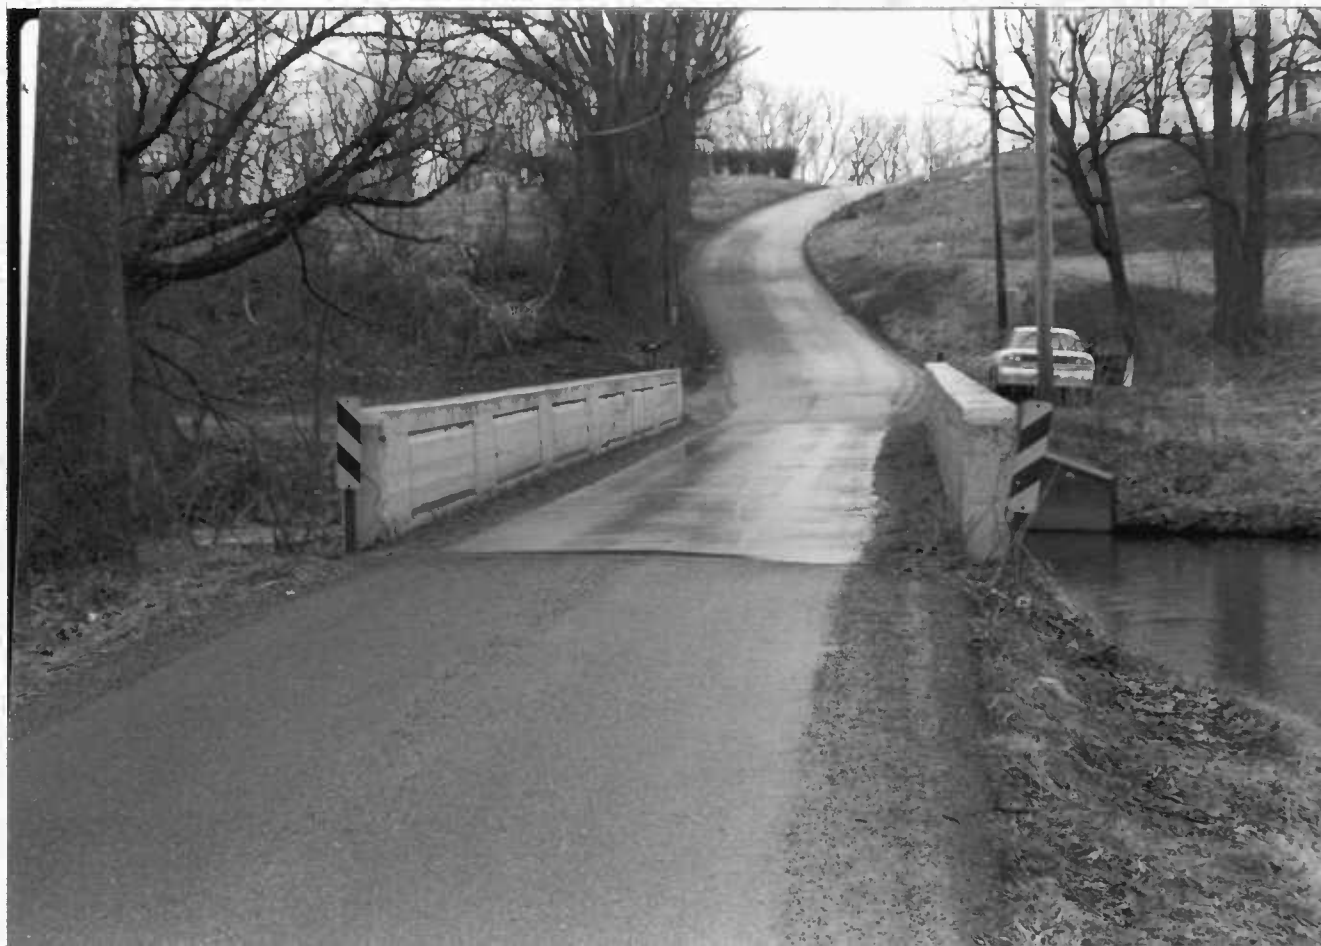
2 OF 4

EAST APPROACH

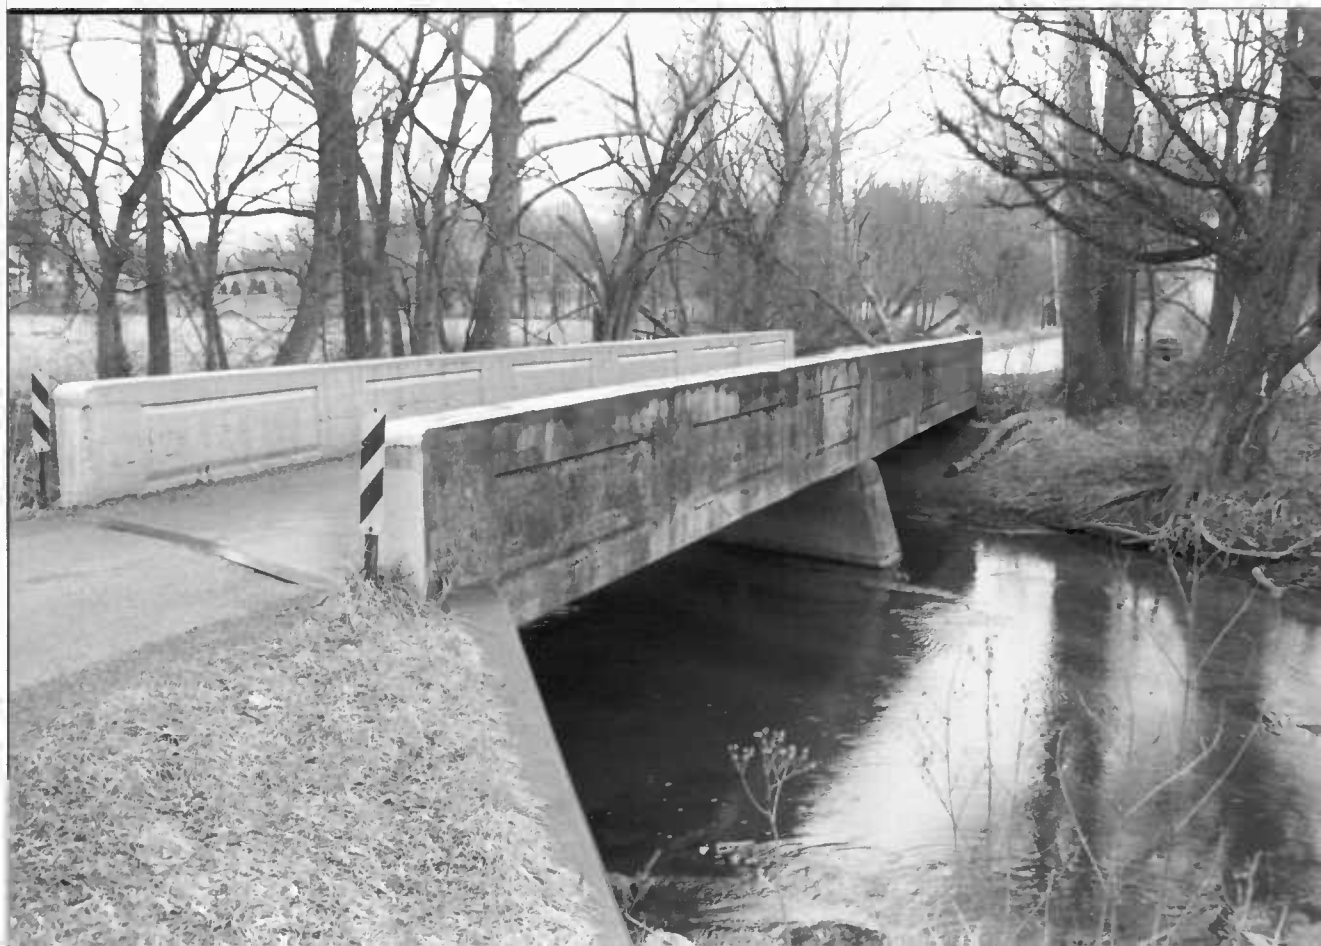
3 OF 4

SOUTH ELEVATION (DOWNSTREAM)

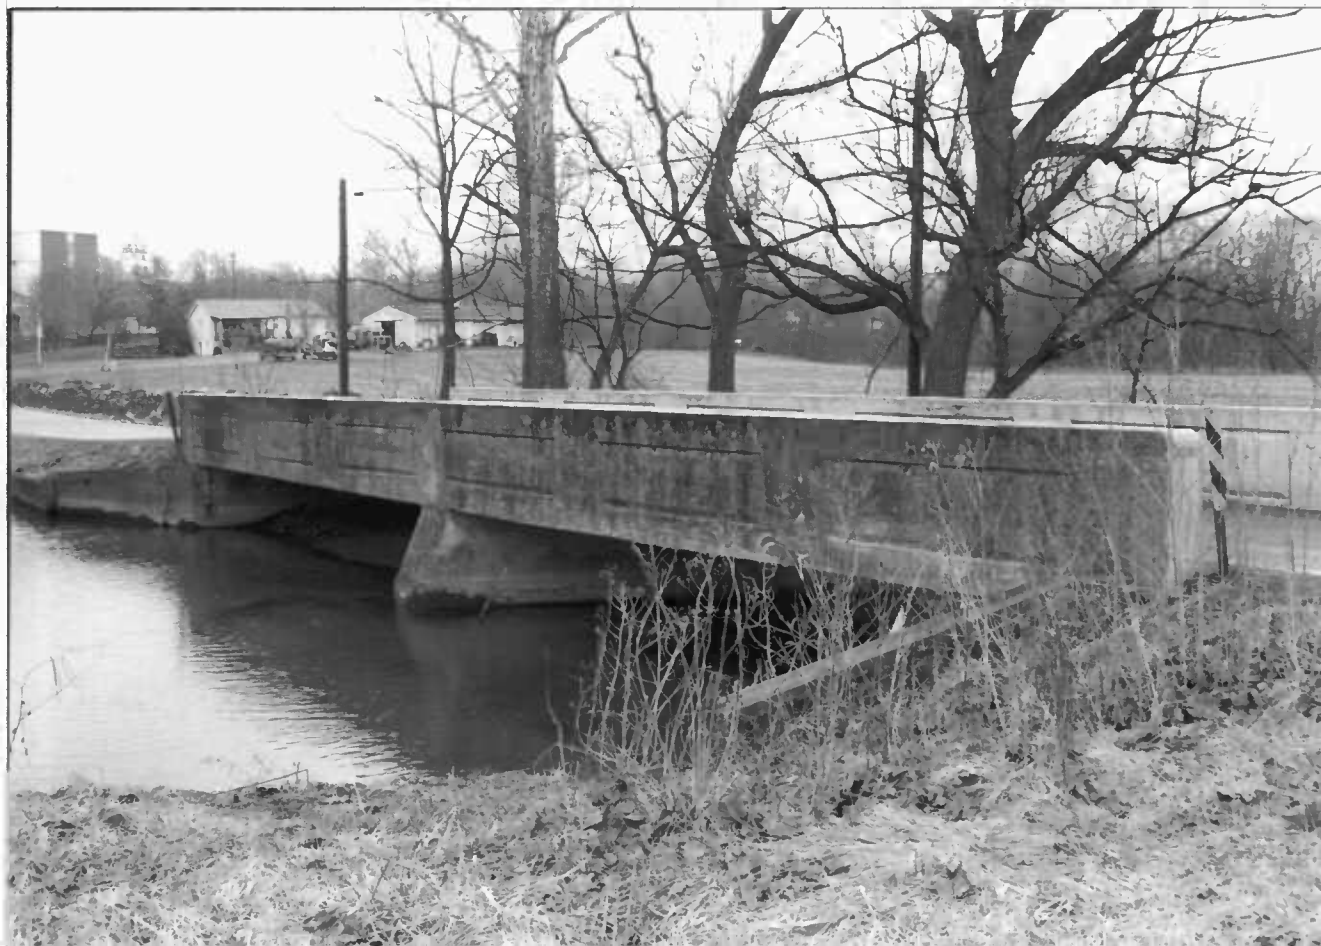
4 OF 4

NORTH ELEVATION (UPSTREAM)
